# ARF Rebuild

by  
Steve Steinbring

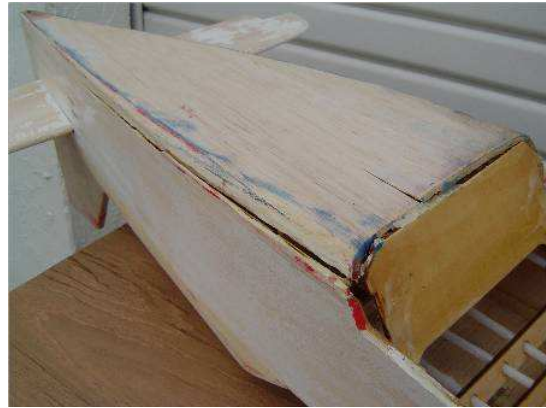
The tail area of the fuselage had a number of fractures, some of the internal bulkheads were also separated in need of repair and gluing.

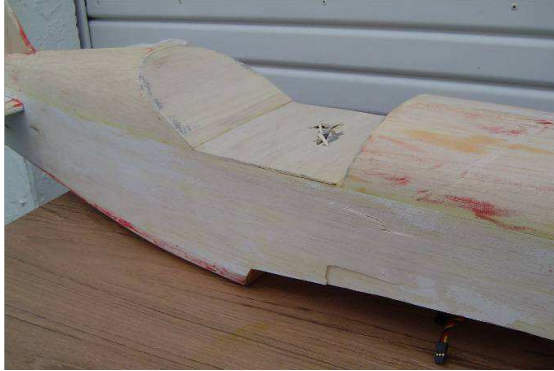
This shot shows some of the damage to the cockpit area and the right side of the fuselage.
