Cowling Repair

Cowling repairs are made easy with Epo-Grip Adhesives!

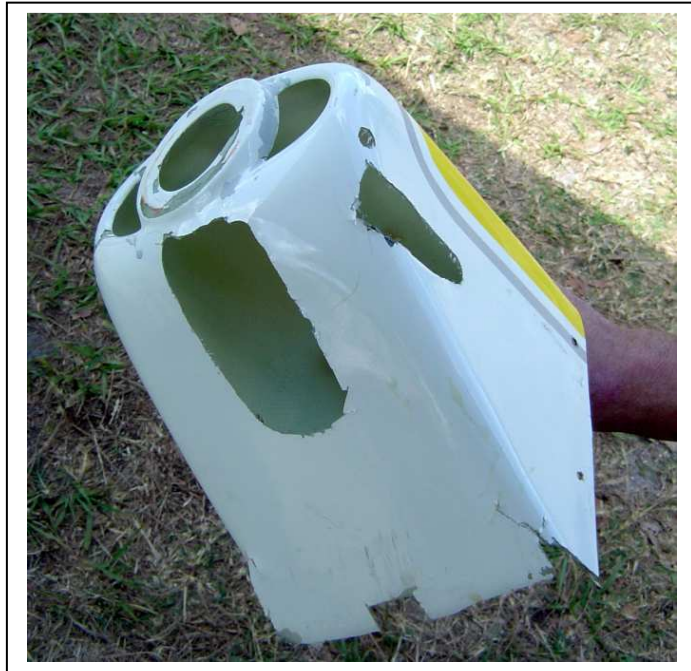
Here is a cowling from an Ultimate 40 Bipe in need of repair, salvaged from a trashcan with the remainder of the bird for rebuild. Although the cowl is badly damaged from poor venting cuts or crashes it is not all that difficult to repair to serviceable condition.

The first step is to thoroughly degrease and sand the cowling before attempting any repairs.

The second step is to stop drill any cracks to prevent further running into the cowl.

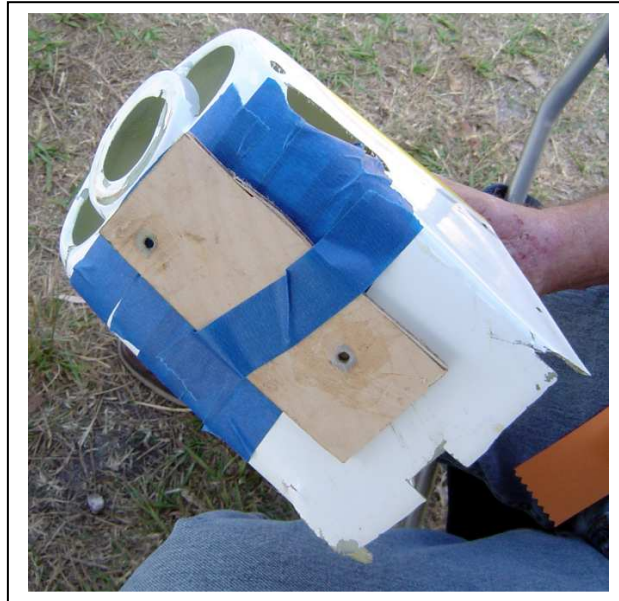
Now we are ready to close up the unwanted open areas of the cowling. A simple method to do this is to apply blue painters tape over the open areas of the cowl to be filled. If the opening to be filled is large using some kind of backing behind the tape for support is a good idea until the adhesive cures. In this repair we used a piece of plywood as support until the adhesive cured.

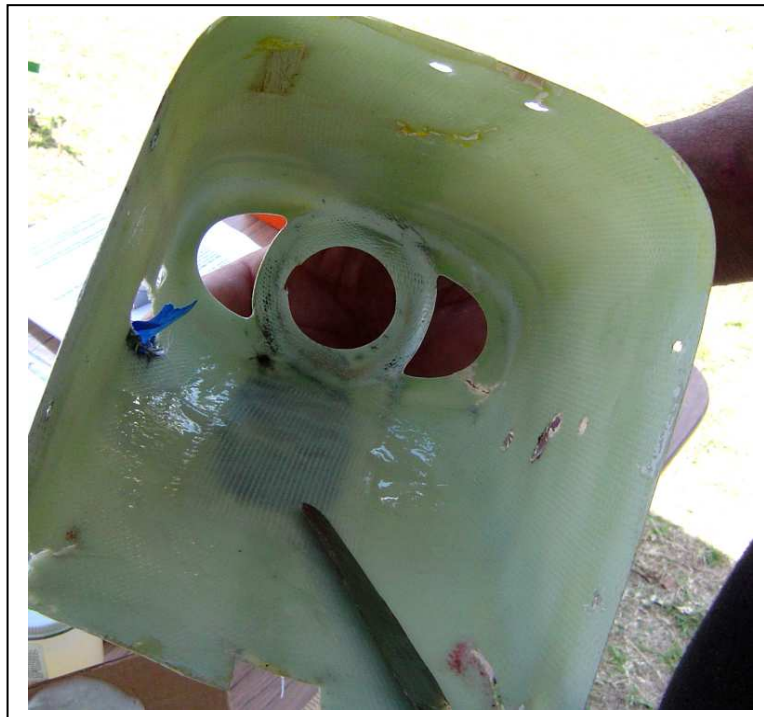
It's now time to fill in the holes. The smaller openings such as needle valve and screw holes only require application of Epo-Grip Model Matrix to the inside of the cowl. Since Model Matrix is a milled fiberglass filled product, it offers its own support for the repair area. For larger openings we use Epo-Grip Clear Paste adhesive and fiberglass tape for reinforcement. The Clear Paste product penetrates the fiberglass tape easier than Model Matrix as it is not filled. Once the adhesive cures remove the backing or tape from the repair area.

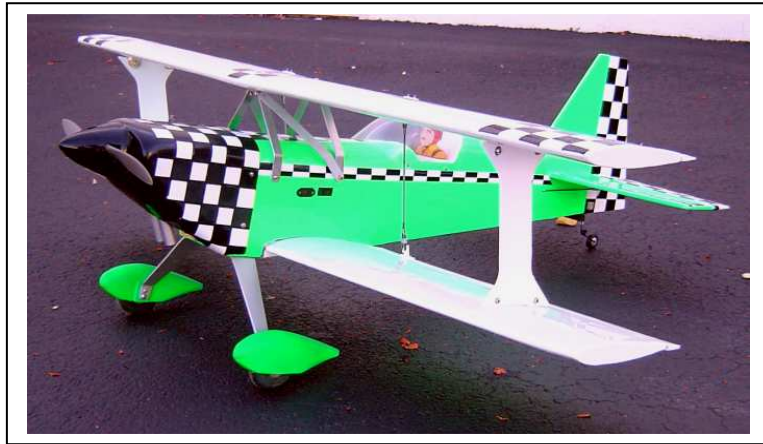
Below is the finished cowl back on the bird!

After you have the cowling openings replaced to your satisfaction its time to sand and prime making the cowl ready for paint. Use auto body glazing putty for removing any final flaws before final priming and paint.
