# ARF Rebuild

by  
Steve Steinbring

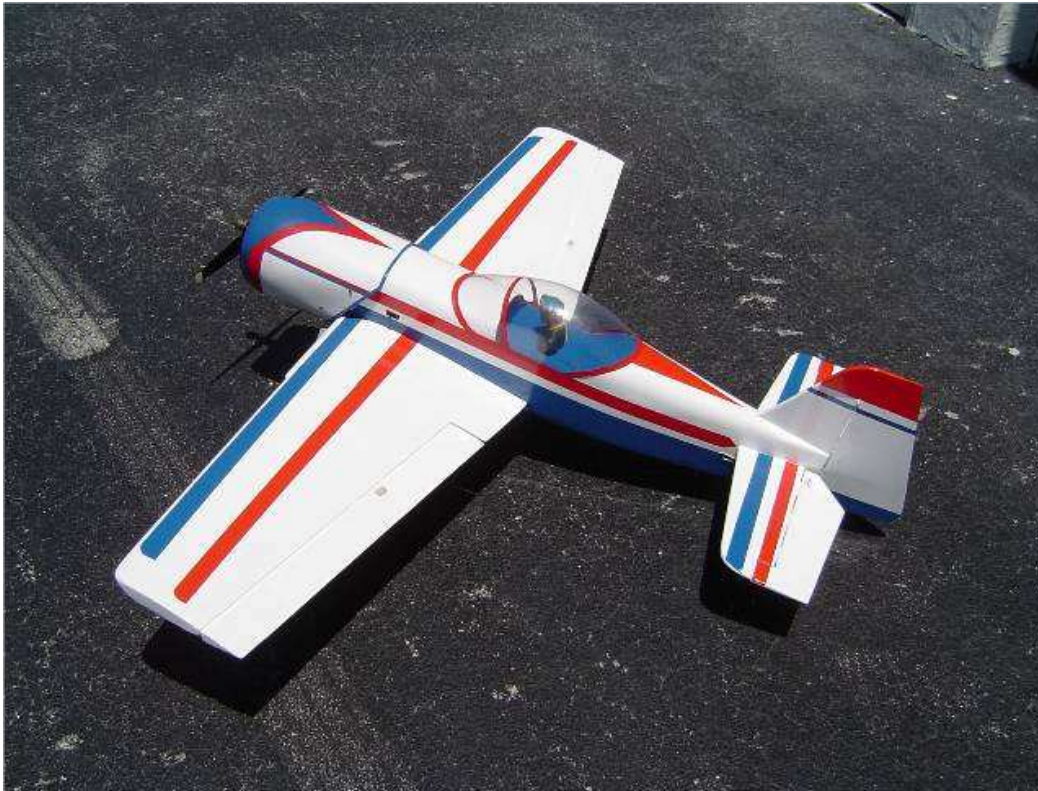
Here's the finished airplane ready to fly again! The haggard looking Sukhoi pilot has a new look to his ride!

The model was recovered using Monokote adding trim for extra color and interest. The repair weight gain with the strengthening was minimal, since the airplane has plenty of power the addition is not even noticeable.
