Cowling Repair

Cowling repairs are made easy with Epo-Grip Adhesives!

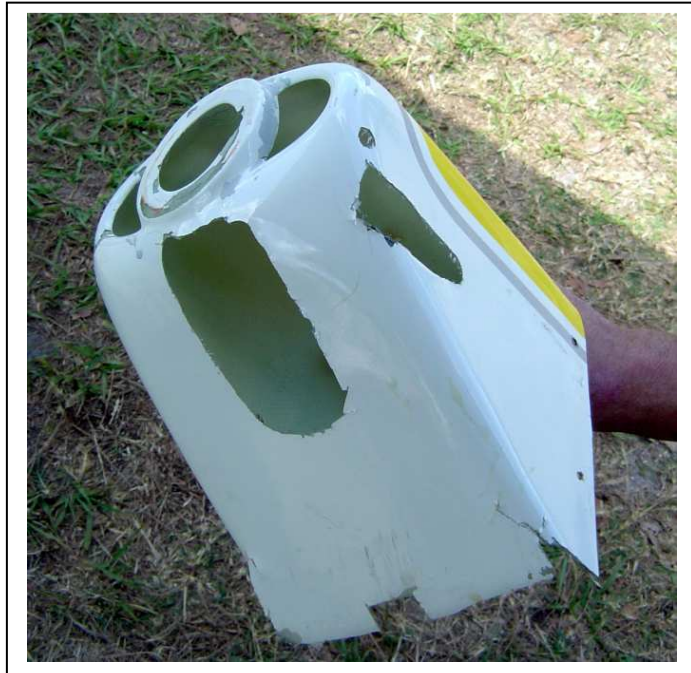
Here is a cowling from an Ultimate 40 Bipe in need of repair, salvaged from a trashcan with the remainder of the bird for rebuild. Although the cowl is badly damaged from poor venting cuts or crashes it is not all that difficult to repair to serviceable condition.

The first step is to thoroughly degrease and sand the cowling before attempting any repairs.

The second step is to stop drill any cracks to prevent further running into the cowl.

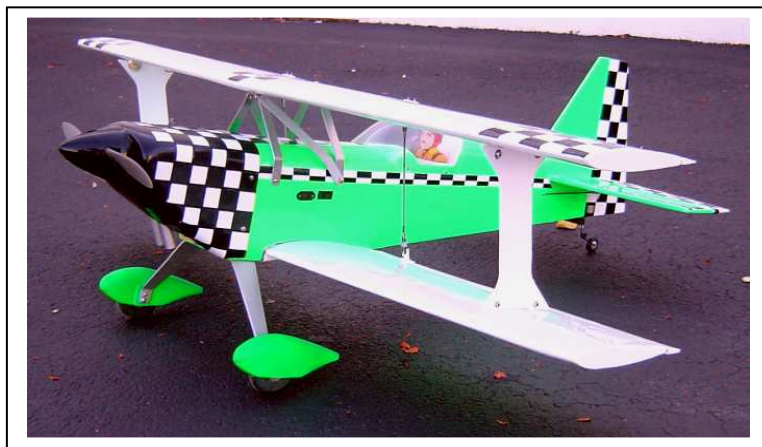
Below is the finished cowl back on the bird!

After you have the cowling openings replaced to your satisfaction its time to sand and prime making the cowl ready for paint. Use auto body glazing putty for removing any final flaws before final priming and paint.
